## Leak located in the ensuite hot water line

12 Example Street, Box Hill VIC 3128

| INSPECTED<br>14 Oct at 12:30 pm | REF<br>Z-2610-EKDNR | PHOTOS<br>3 |

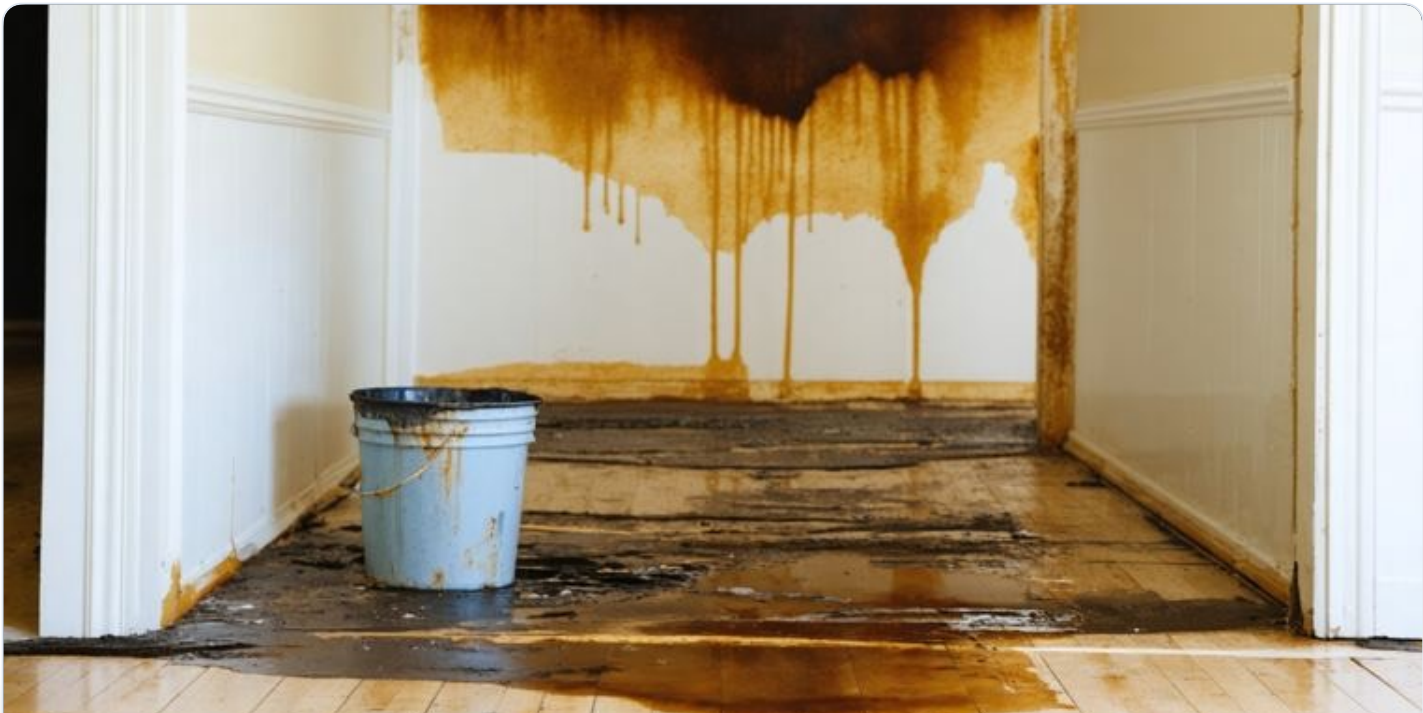
PHOTO 1 OF 3  
Staining and pooling in the hallway below the ensuite

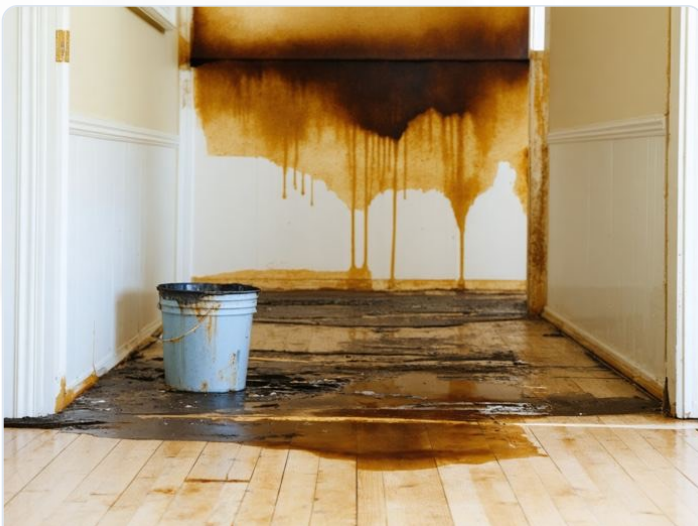
### 1 / 3 · PHOTO

Water staining and pooling in the hallway below the ensuite.

Staining and pooling in the hallway below the ensuite

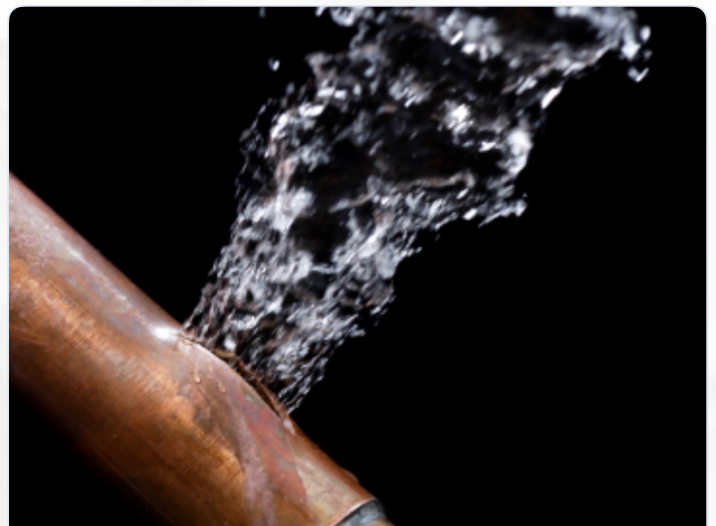
### 2 / 3 · PHOTO

The hot line dropped from **1500 kPa** to **900 kPa** in **15 minutes**. Thermal imaging showed a warm plume behind the shower wall. The cold line **held pressure**.

Hot water line behind the ensuite shower wall, **600 mm** above floor level.

**Failed** fitting on the hot water line inside the wall cavity.

Failed fitting on the hot line once exposed

- Open the wall and replace the **failed** fitting.
- Dry the cavity and re-test before re-sheeting.

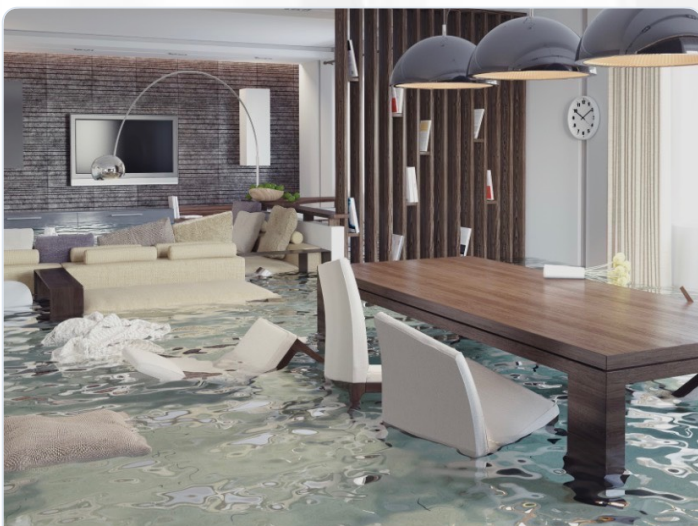
### 3 / 3 · PHOTO

Water across the downstairs floor
