## Storm-lifted ridge capping, water into the hallway ceiling

12 Example Street, Box Hill VIC 3128

| INSPECTED<br>14 Oct at 12:30 pm | REF<br>Z-2610-3EDXR | PHOTOS<br>3 |

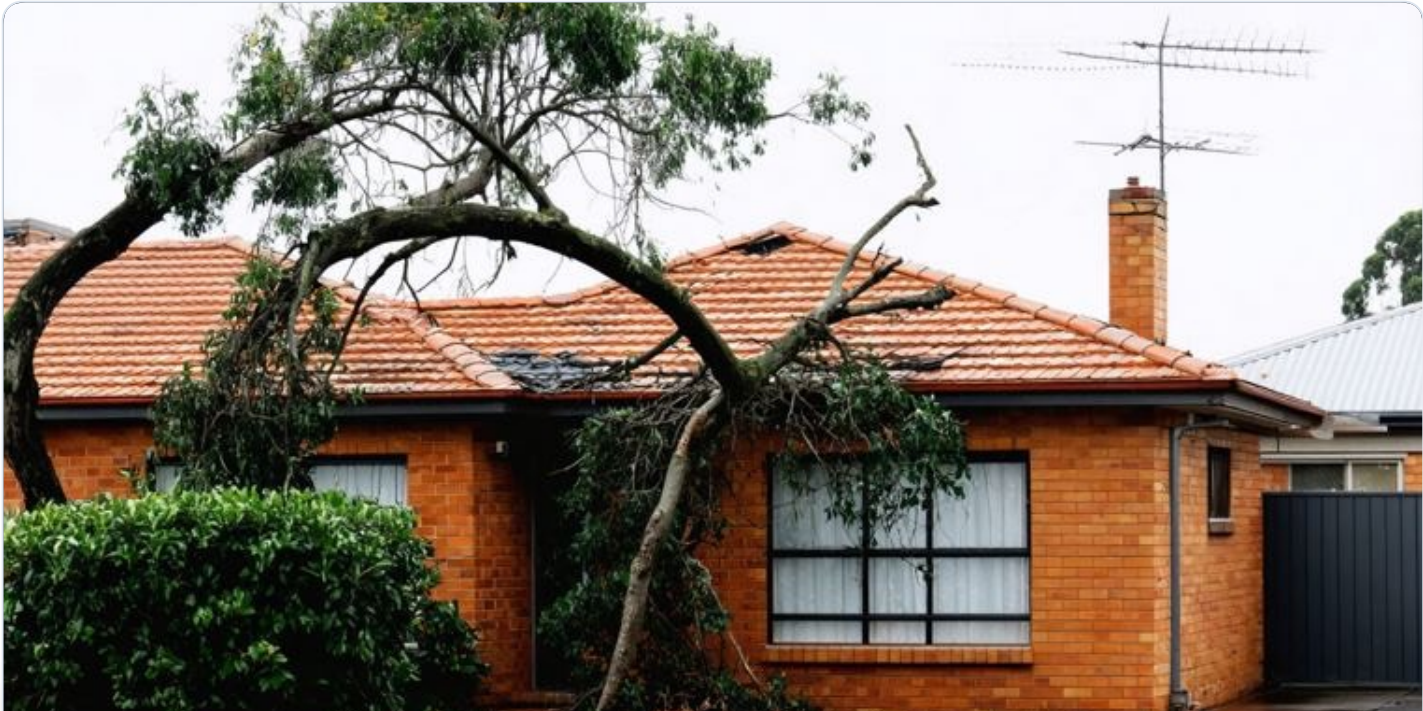
PHOTO 1 OF 3  
Front of the property, tree down across the roof line

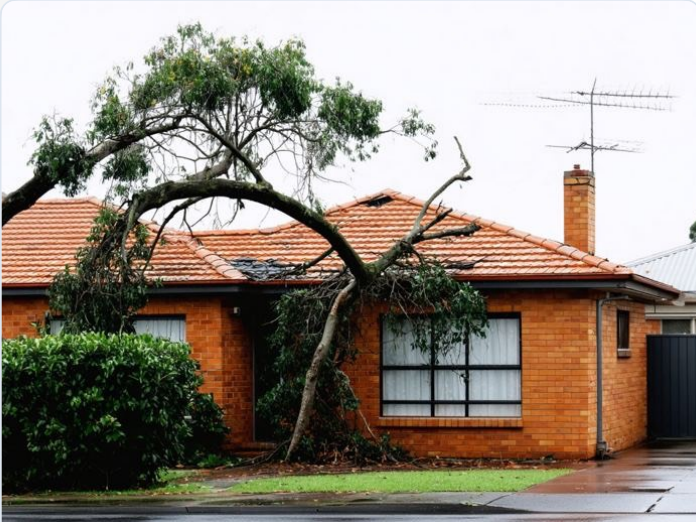
1 / 3 · PHOTO

A tree limb is resting against the front gutter line.

Front of the property, tree down across the roof line

- Re-bed and re-point the full ridge line.
- Replace six **broken** tiles.
- Have the tree limb **removed** before the gutter is refitted.

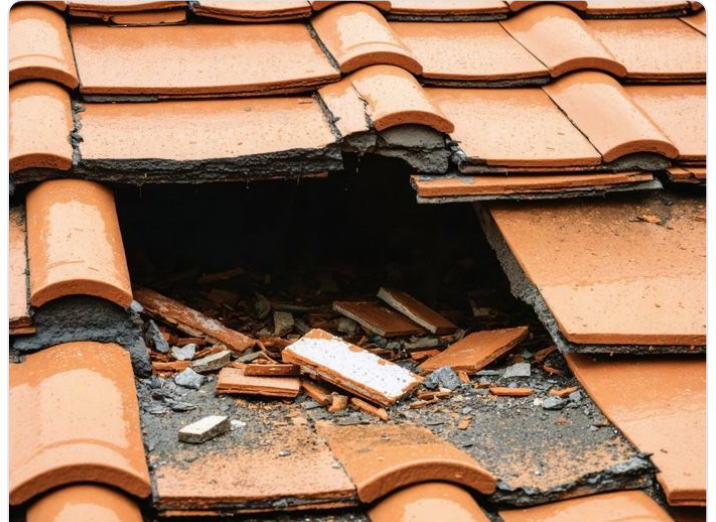
2 / 3 · PHOTO

Wind lifted the ridge capping on the north face, leaving six tiles **dislodged** and an opening above the hallway.

Pointing along **4 m** of ridge is **cracked** and **porous**.

Dislodged tiles and opening on the north face

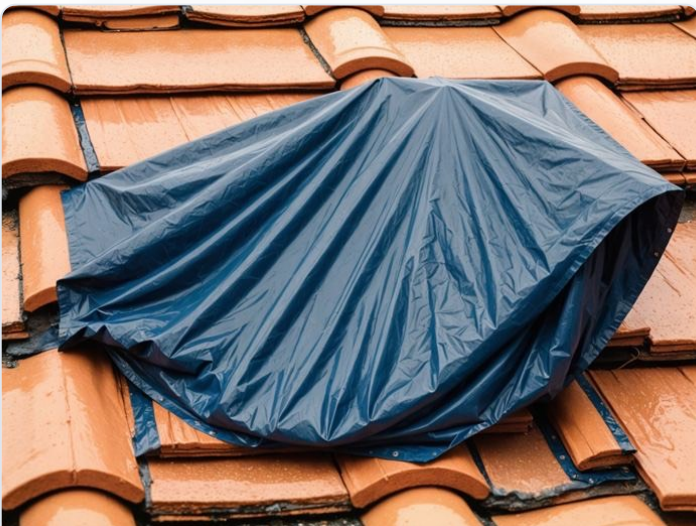
3 / 3 · PHOTO

Opening tarped as a temporary cover
